# Manhole Inspection Summary

Manhole # S33Q\_\_028MH

Insp Date: **3/17/08 11:32 AM**

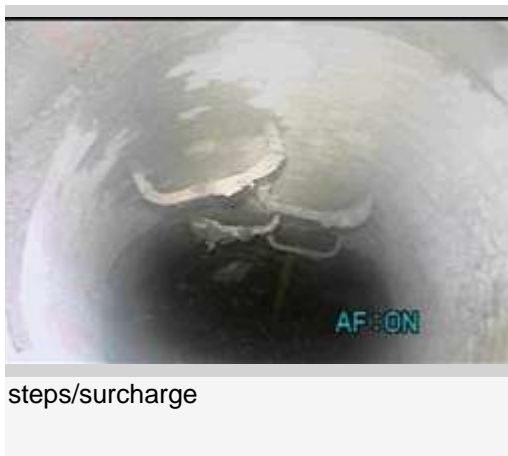
Defect 2

**Steps** Count: **5** Missing: **0** ☒ **Corroded**

**Surcharge** ☒ **Evidence Of Surcharge** Depth: **6** (ft.) ☐ Active Surcharge Present

steps/surcharge

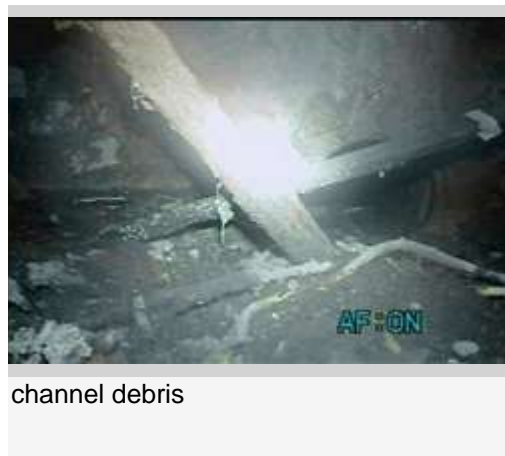
Defect 4

Condition: ☐ Sound ☐ Cracked ☐ Root Intrusion ☐ Deteriorated ☐ Leaks ☒ **Debris**

channel debris

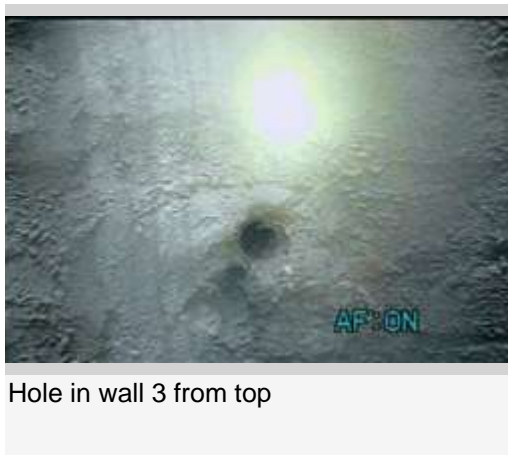
Defect 3

Hole in wall 3 from top

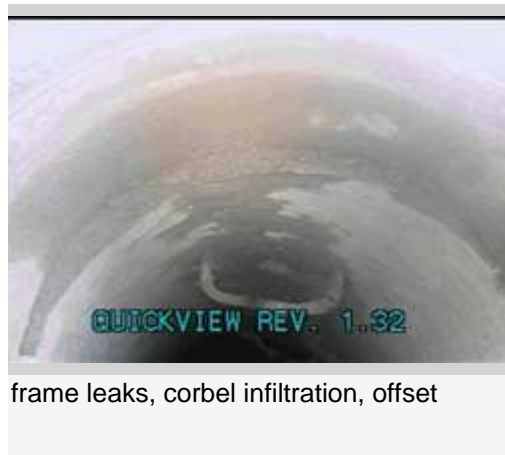
Defect 1

**Frame** Offset: **1** (in.) Condition: ☐ Sound ☐ Cracked ☒ **Leaks**

Condition: ☐ Sound ☐ Cracked ☐ Root Intrusion ☐ Loose Brick ☒ **Deteriorated**

Infiltration: ☐ None ☐ Joint ☐ Cracks ☐ Mortar ☐ Roots ☒ **Wall**

frame leaks, corbel infiltration, offset
